REPORT NO. SP-1622

**MODEL** U-2R

**TITLE** TEST OF EJECTION SEAT  
CANOPY BREAKER EXTENSION

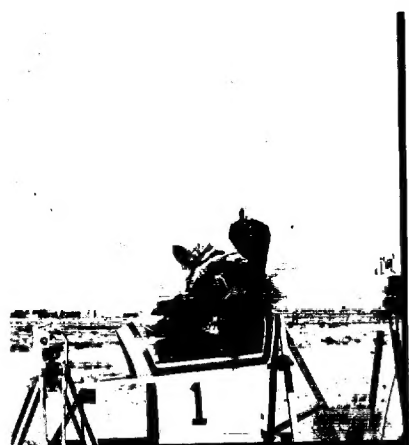
1. Prior to firing.
2. The initiator has fired the catapult and the seat has moved up to contact the glass. Note the black smoke from the initiator coming up the aft bulkhead. This occurs after the catapult moves the rocket up far enough to separate the mated connections of the initiator line.
3. The catapult has forced the Canopy Breaker through the canopy.
4. The pilot and seat are emerging through the canopy and the rocket has ignited.
5. The seat has cleared the tracks and the Seat Drogue Chute Gun has fired to deploy the stabilizing chute.
6. The test is successful.
